# Ellicott Creek Park Living Shoreline Project

This project was completed in 2017 with support from the Greenway Ecological Fund and in partnership with Erie County Department of Parks, Recreation and Forestry and Ecological Restoration Inc.

## LIVING SHORELINES ELLICOTT CREEK PARK

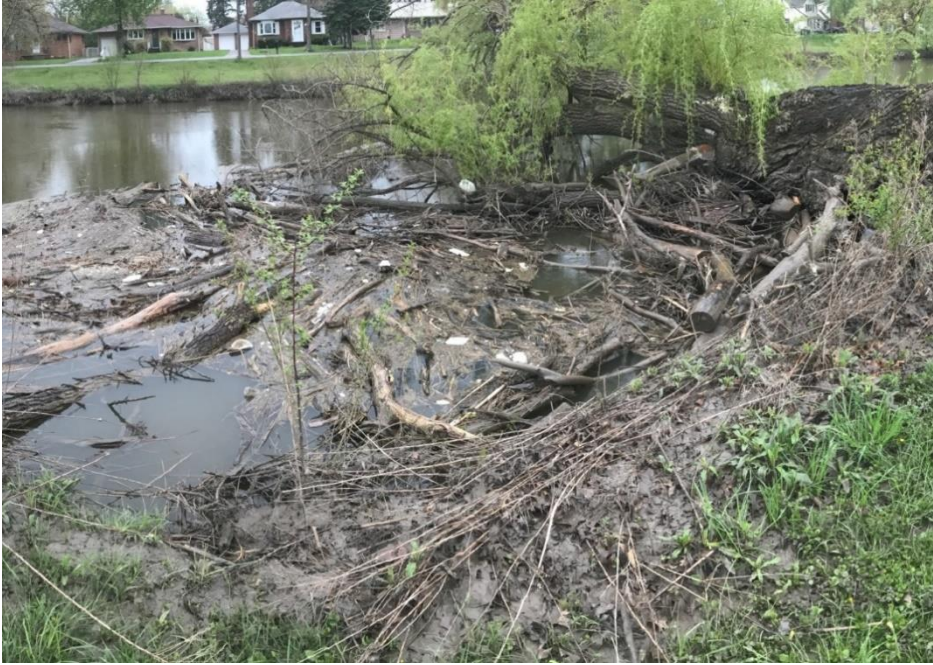
**BEFORE**

The shoreline you see here today once looked very different. Before this "Living Shoreline" was created, turf lawn and invasive plants dominated the shoreline (shown above). In-water habitat was lacking and poor water quality conditions resulted from bank erosion and untreated runoff discharging directly into the creek. Shoreline erosion and bank undercutting was caused primarily by daily fluctuations in water levels and a lack of vegetation.

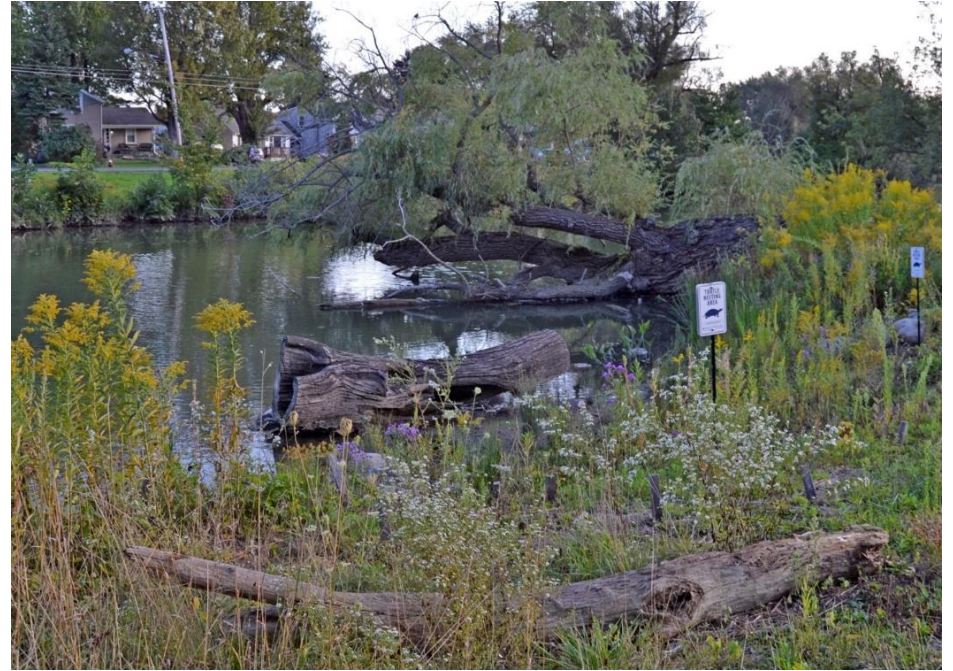
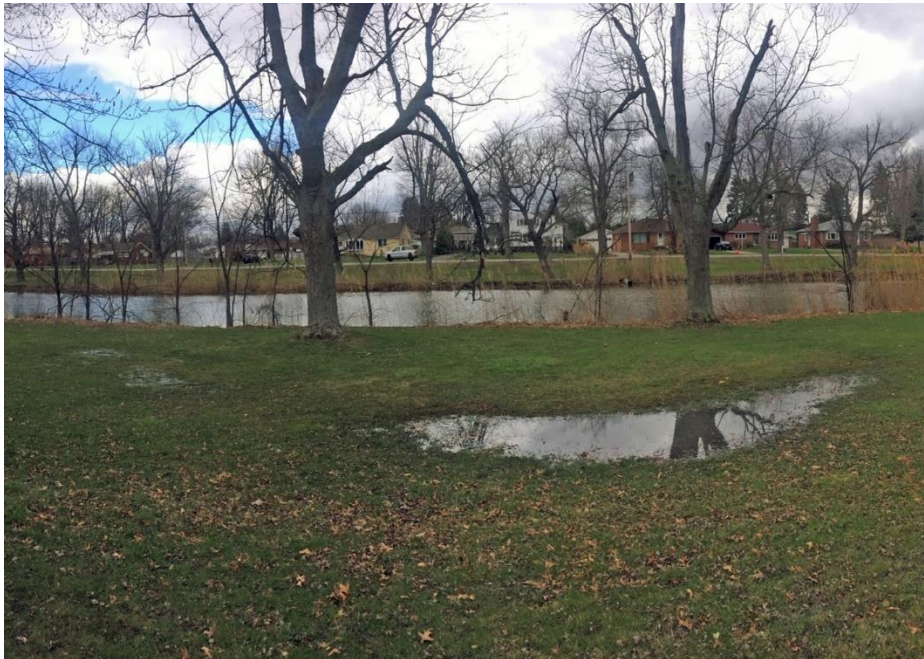
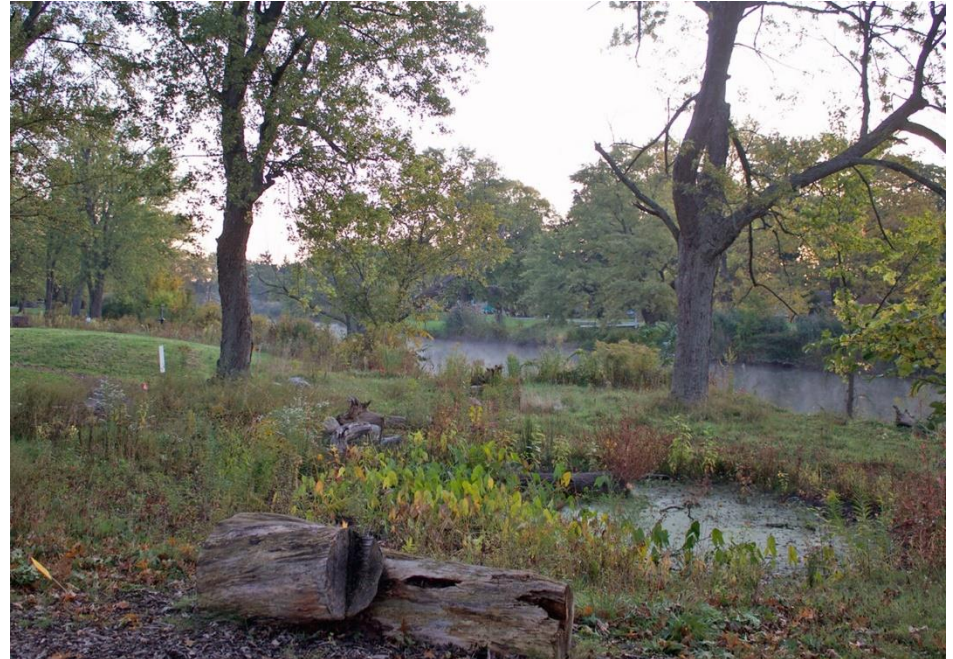
**AFTER**

Living Shoreline projects restore gradual slopes, protect shorelines with logs and boulders, and re-establish native plants to create a more natural and seamless transition between land and water. It is estimated that 90% of life found in freshwater ecosystems is born and raised in these vital water-land transition areas. The Living Shoreline here at Ellicott Creek Park re-establishes this "ribbon of life" along the water's edge, supporting numerous wildlife species including bats, waterbirds, fish, amphibians, and beneficial insects. This restored shoreline also provides improved public access and recreational opportunities for park visitors. The photograph above shows the conditions as they were just after construction in October 2017.
